Manhole Inspection Summary

Manhole # S41SS_006MH

Insp Date: **2/19/07 9:39 AM**

Location Address: **1552 MONTPELIER ST**

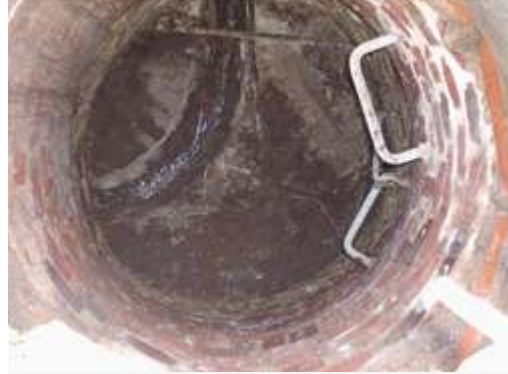
Top View

Bench ☒ Exists Material: **Brick** ☐ Parged ☒ **Debris** (not Condition related)

Surcharge ☒ **Evidence Of Surcharge** Depth: **1.5** (ft.) ☐ Active Surcharge Present

Evidence of surcharge - Bench debris.

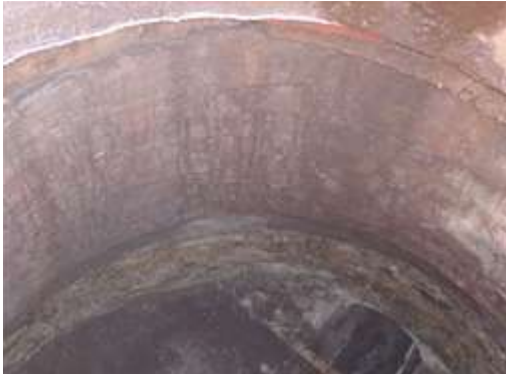
Defect

Frame Offset: **2** (in.) Condition: ☐ Sound ☐ Cracked ☒ **Leaks**

Condition: ☐ Sound ☐ Cracked ☐ Root Intrusion ☐ Loose Brick ☒ **Deteriorated**

Infiltration: ☐ None ☒ **Joint** ☐ Cracks ☐ Mortar ☐ Roots ☒ **Wall**

Frame leaks. Adjustment deterioration and infiltration.

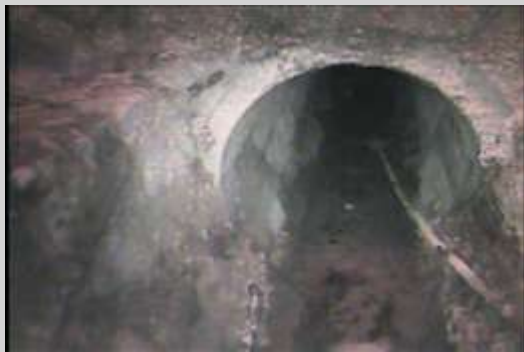
8 in. Circular Gravity Sewer Pipe Out @ 12 O'Clock

Invert Depth: **7.32** (ft.) Flow Characteristics: **Slow**

Deposits: ☒ None ☐ Mud ☐ Sludge ☐ Debris ☐ Grease

Infiltration: **None** Pipe Seal Cond: **Unknown**

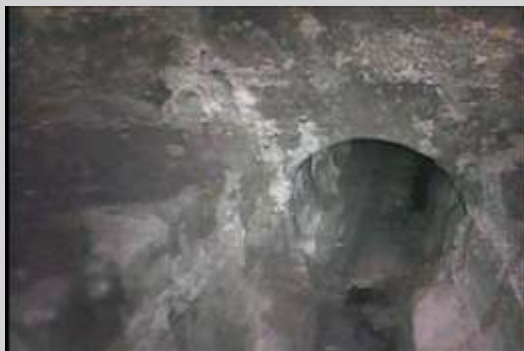
8 in. Circular Gravity Sewer Pipe In @ 9 O'Clock

Invert Depth: **6.98** (ft.) Flow Characteristics: **Slow**

Deposits: ☒ None ☐ Mud ☐ Sludge ☐ Debris ☐ Grease

Infiltration: **None** Pipe Seal Cond: **Unknown**
